Framing Failures in Wood-Frame Hip Roofs under Extreme Wind Loads

Sarah A. Stevenson¹, Gregory A. Kopp^{1*} and Ayman M. El Ansary²

Wood-frame residential roof failures are among the most common and expensive types of wind damage. Hip roofs are commonly understood to be more resilient during extreme wind in relation to gable roofs. However, inspection of damage survey data from recent tornadoes has revealed a previously unstudied failure mode in which hip roofs suffer partial failure of the framing structure. In the current study, evidence of partial framing failures and statistics of their occurrence are explored and discussed, while the common roof design and construction practice are reviewed. Two-dimensional finite element models are developed to estimate the element-level load effects on hip roof trusses and stick-frame components. The likelihood of failure in each member is defined based on relative demand-to-capacity ratios. Trussed and stick-frame structures are compared to assess the relative performance of the two types of construction. The present analyses verify the common understanding that toenailed roof-to-wall connections are likely to be the most vulnerable eleme

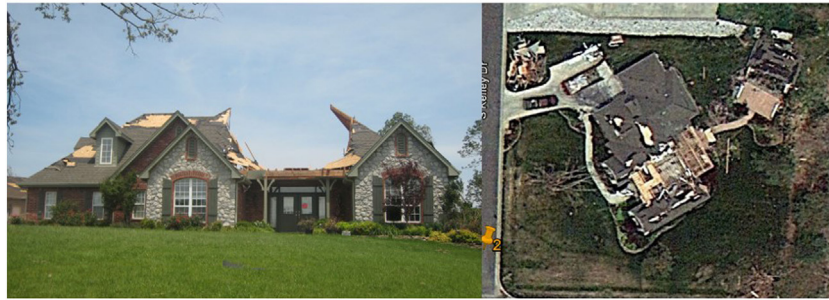
of failure of the RTWC. **Figure 5** shows an example of the steep-sloping hip roofs visible throughout this neighborhood, with an aerial image showing how the surface area of the roof was affected by the failure. In many instances, the largest surfaces of the roof were removed, while parts of the structure enclosing smaller spaces remained in place. Many of these structures also appeared to be of stick-frame construction.

FIGURE 5 | Example of typical hip roof failure in Region 1, including an aerial photo showing the footprint of the partial failure (image source: Dr. David Prevatt, Google Earth).

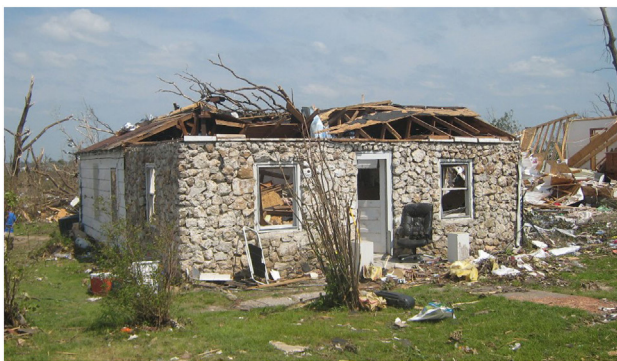
FIGURE 6 | Partial hip roof failure in Region 2 (image source: Dr. David Prevatt).

ambiguous, and because Region 2 was downwind of Region 1, debris likely played a larger role. In any case, in both regions, partial failures are found to occur at least as often as other modes of roof failure. More work is required to obtain a complete set of statistics on these failures and better define the regional conditions that may contribute to their occurrence.
